**Flood Control Project Maintenance  
Levee Inspections**

**Fall 2013 Levee Maintenance Deficiency Summary Report**

**Sacramento River Basin**

**Marysville Levee Commission**

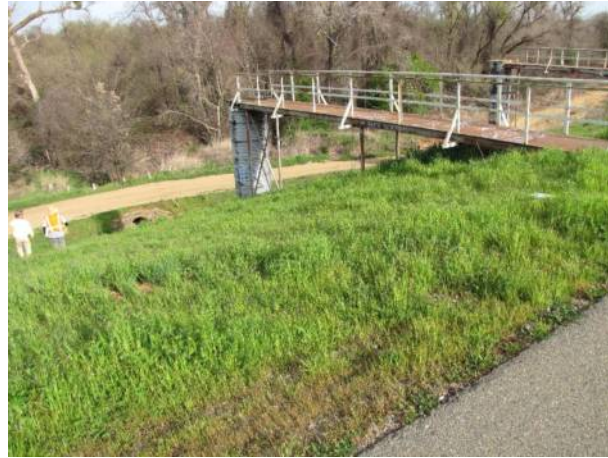
UCIP\_5749.jpg

View of CMP riser and walkway located on waterward slope.

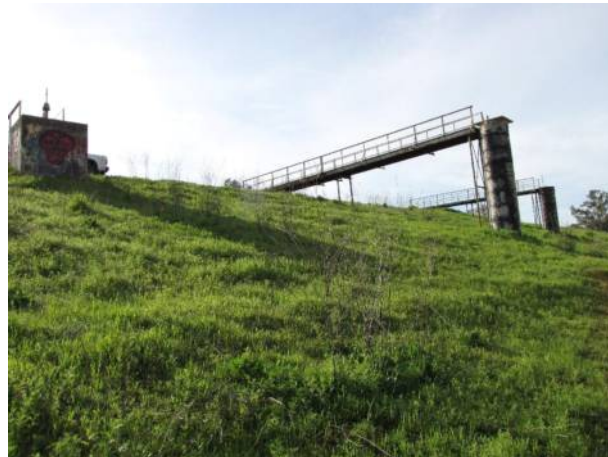
Levee Mile Report Line	16
Start Levee Mile	0.43
End Levee Mile	0.43
Location	Land Side
Category	Supplemental
Item	DWR UCIP Field Study

View of waterward side--walkway and CMP riser.

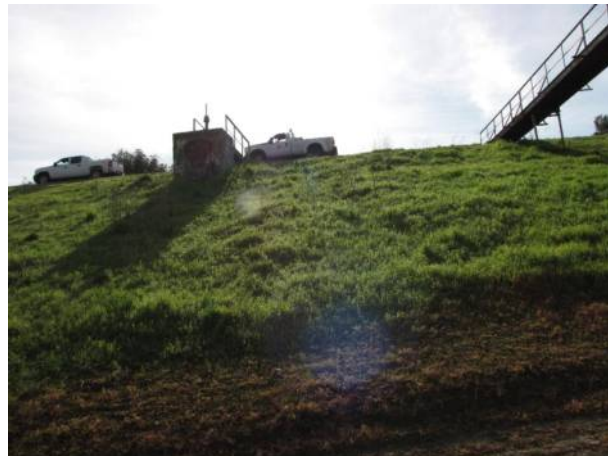
Levee Mile Report Line	20
Start Levee Mile	0.44
End Levee Mile	0.44
Location	Land Side
Category	Supplemental
Item	DWR UCIP Field Study

View of waterward side. Concrete box with gate stem through top.

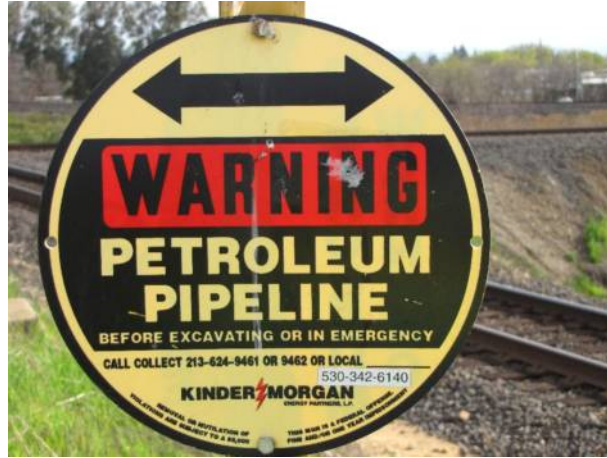
UCIP\_5798.jpg

Marker visible on landward side.

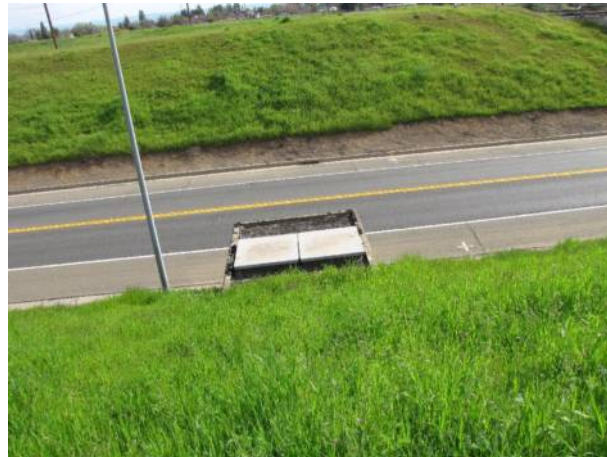
Levee Mile Report Line	26
Start Levee Mile	0.92
End Levee Mile	0.92
Location	Land Side
Category	Supplemental
Item	DWR UCIP Field Study

View of landward side.

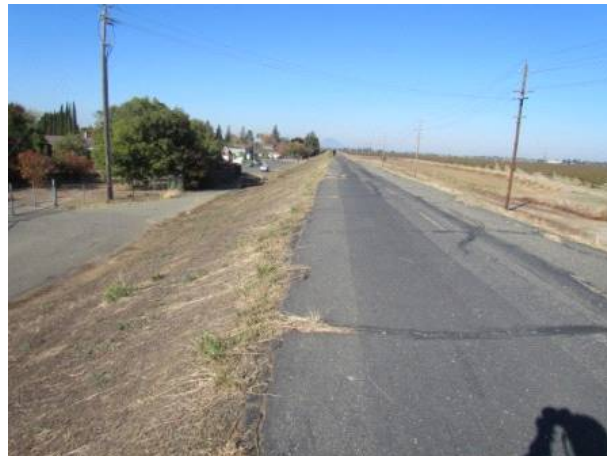
Levee Mile Report Line	33
Start Levee Mile	3.16
End Levee Mile	3.16
Location	Land Side
Category	Earthen Levee
Item	Vegetation

This photo was taken from the crown facing west looking down the landward levee slope at acceptable vegetation maintenance. Fall 2013.

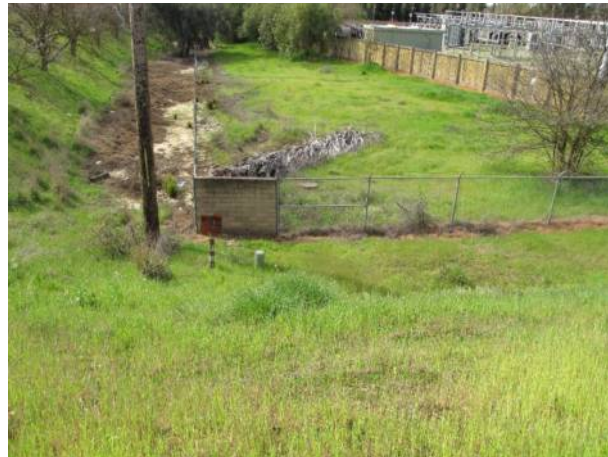
Levee Mile Report Line	36
Start Levee Mile	3.23
End Levee Mile	3.23
Location	Land Side
Category	Supplemental
Item	DWR UCIP Field Study

View of landward slope covered by vegetation.

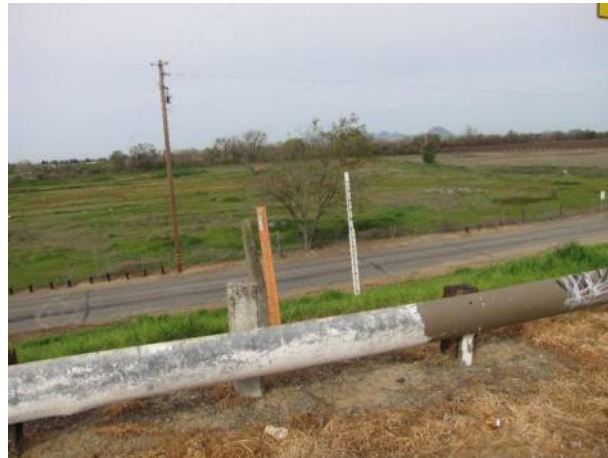
UCIP\_5834.jpg

View of waterward side, marker located on waterward shoulder.

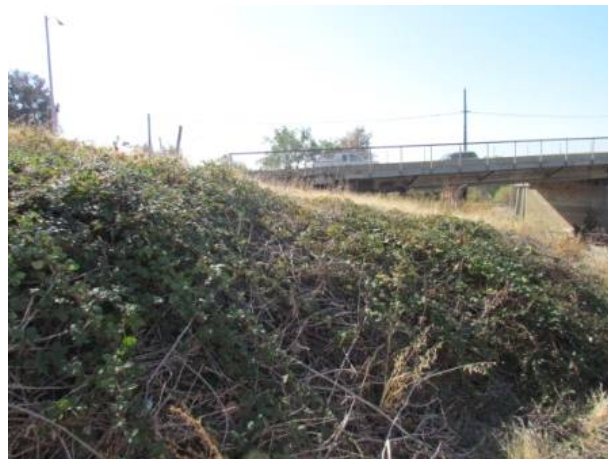
Levee Mile Report Line	3
Start Levee Mile	0.72
End Levee Mile	0.72
Location	Water Side
Category	Earthen Levee
Item	Vegetation

This photo was taken from the access road going under the 5th street bridge of blackberries growing on the waterward levee slope. Fall 2013.

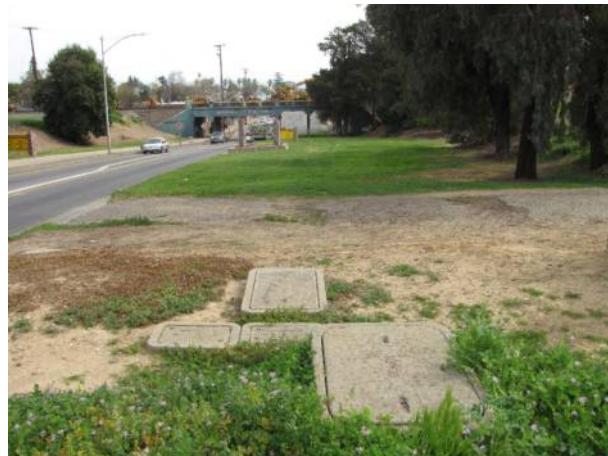
Levee Mile Report Line	4
Start Levee Mile	0.74
End Levee Mile	0.74
Location	Water Side
Category	Supplemental
Item	DWR UCIP Field Study

Concrete service boxes for sewer, water, and electrical lines.

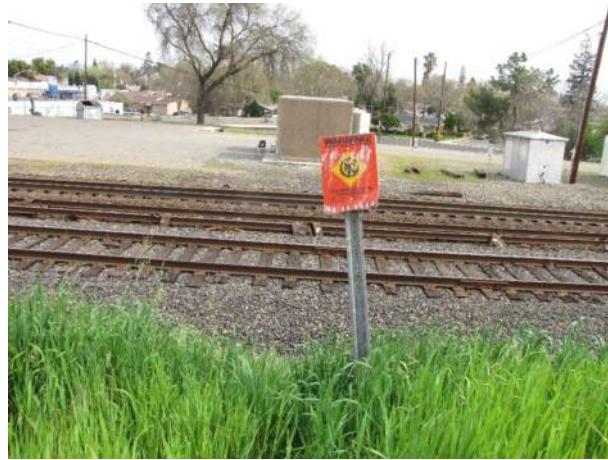
UCIP\_5850.jpg

View of landward side with bldg that could be associated with cable line.

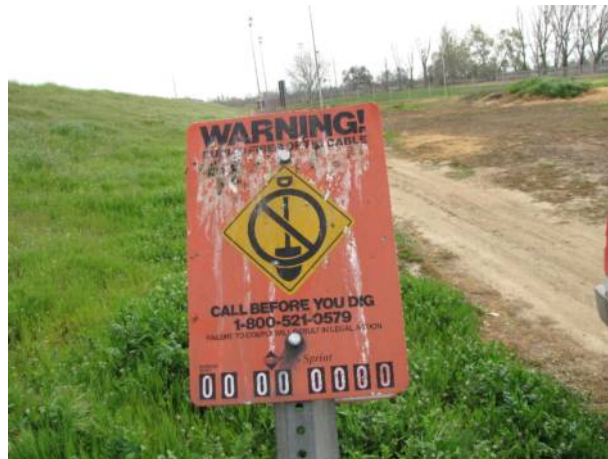
Levee Mile Report Line	9
Start Levee Mile	0.93
End Levee Mile	0.93
Location	Water Side
Category	Supplemental
Item	DWR UCIP Field Study

Close up of markers located at toe of waterward side.

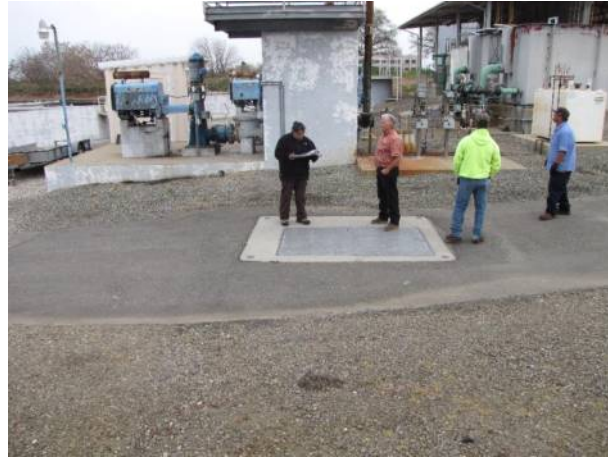
UCIP\_5857.jpg

View of vault located inside Marysville Wastewater Treatment Facility.

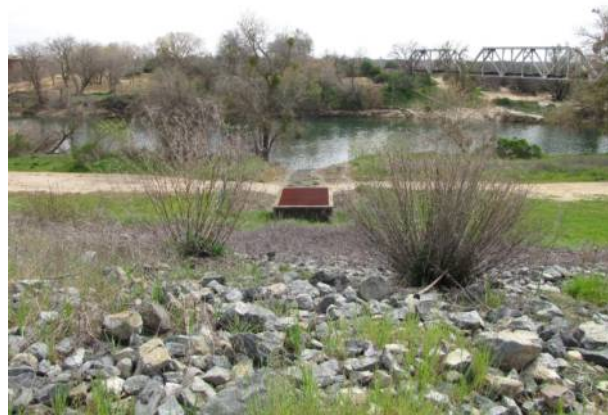
Levee Mile Report Line	3
Start Levee Mile	0.13
End Levee Mile	0.13
Location	Land Side
Category	Supplemental
Item	DWR UCIP Field Study

Distribution box located on waterward slope.

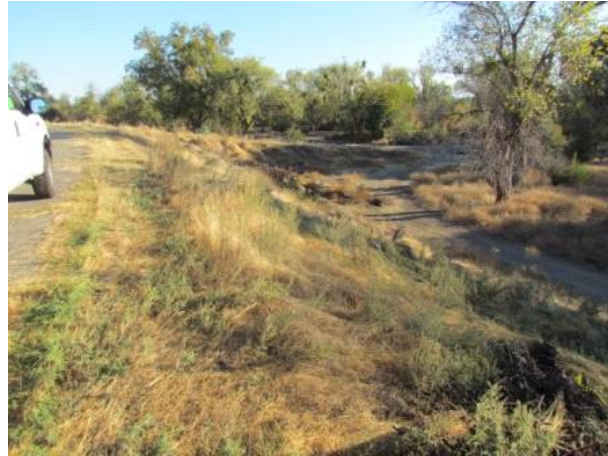
mhoffman\_f\_20131031\_690.JPG

This photo was taken from the crown facing east looking down the waterward levee slope at vegetation. Fall 2013.

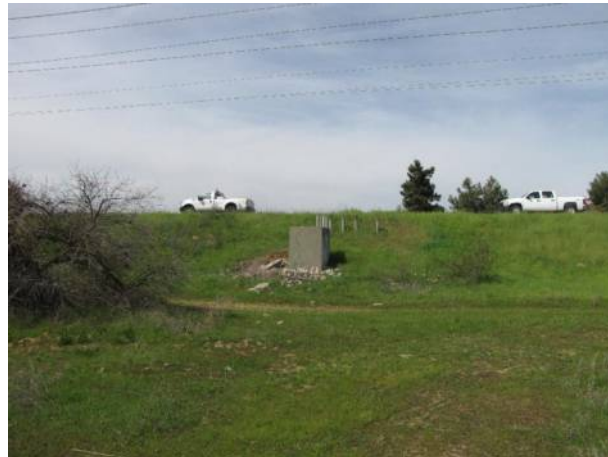
Levee Mile Report Line	20
Start Levee Mile	2.23
End Levee Mile	2.23
Location	Land Side
Category	Supplemental
Item	DWR UCIP Field Study

View of waterward side--concrete distribution box and gate stems located on waterward slope.

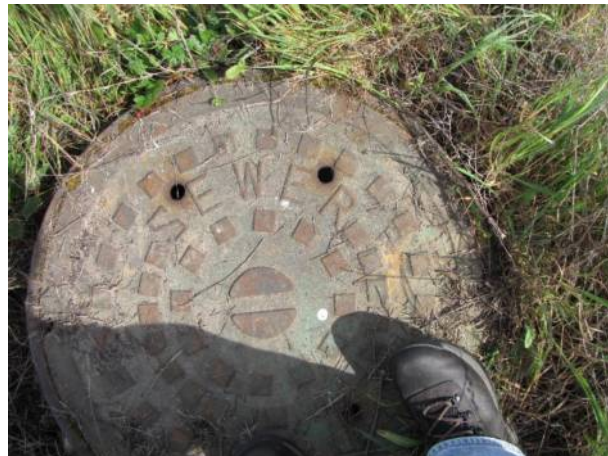
Levee Mile Report Line	30
Start Levee Mile	3.25
End Levee Mile	3.25
Location	Land Side
Category	Supplemental
Item	DWR UCIP Field Study

Manhole located on landward toe.

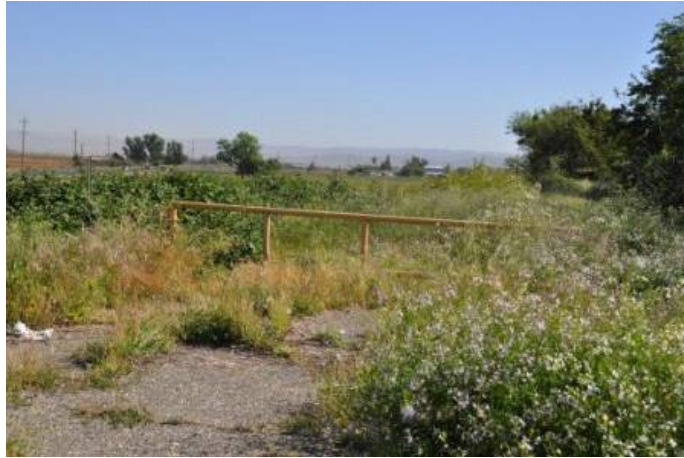
mhoffman\_f\_20130917\_038.JPG

Marysville, Unit 3 - Spring 2013 - Patrol road vegetation.

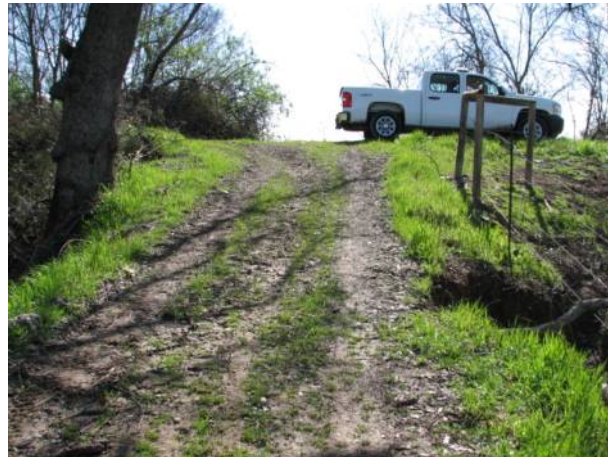
Levee Mile Report Line	33
Start Levee Mile	5.54
End Levee Mile	5.54
Location	Crown
Category	Earthen Levee
Item	Encroachments

This ramp is on the patrol road, no known permit.
